RE MVN-2011-03213-MB: Revision 1 of the Ponderosa Ranch of Pointe Coupee Mitigation Bank Draft Mitigation Banking Instrument

Ponderosa Ranch of Pointe Coupee Mitigation Bank
Mitigation Banking Instrument

Mitigation Work Plan
Ponderosa Ranch of Pointe Coupee Mitigation Bank

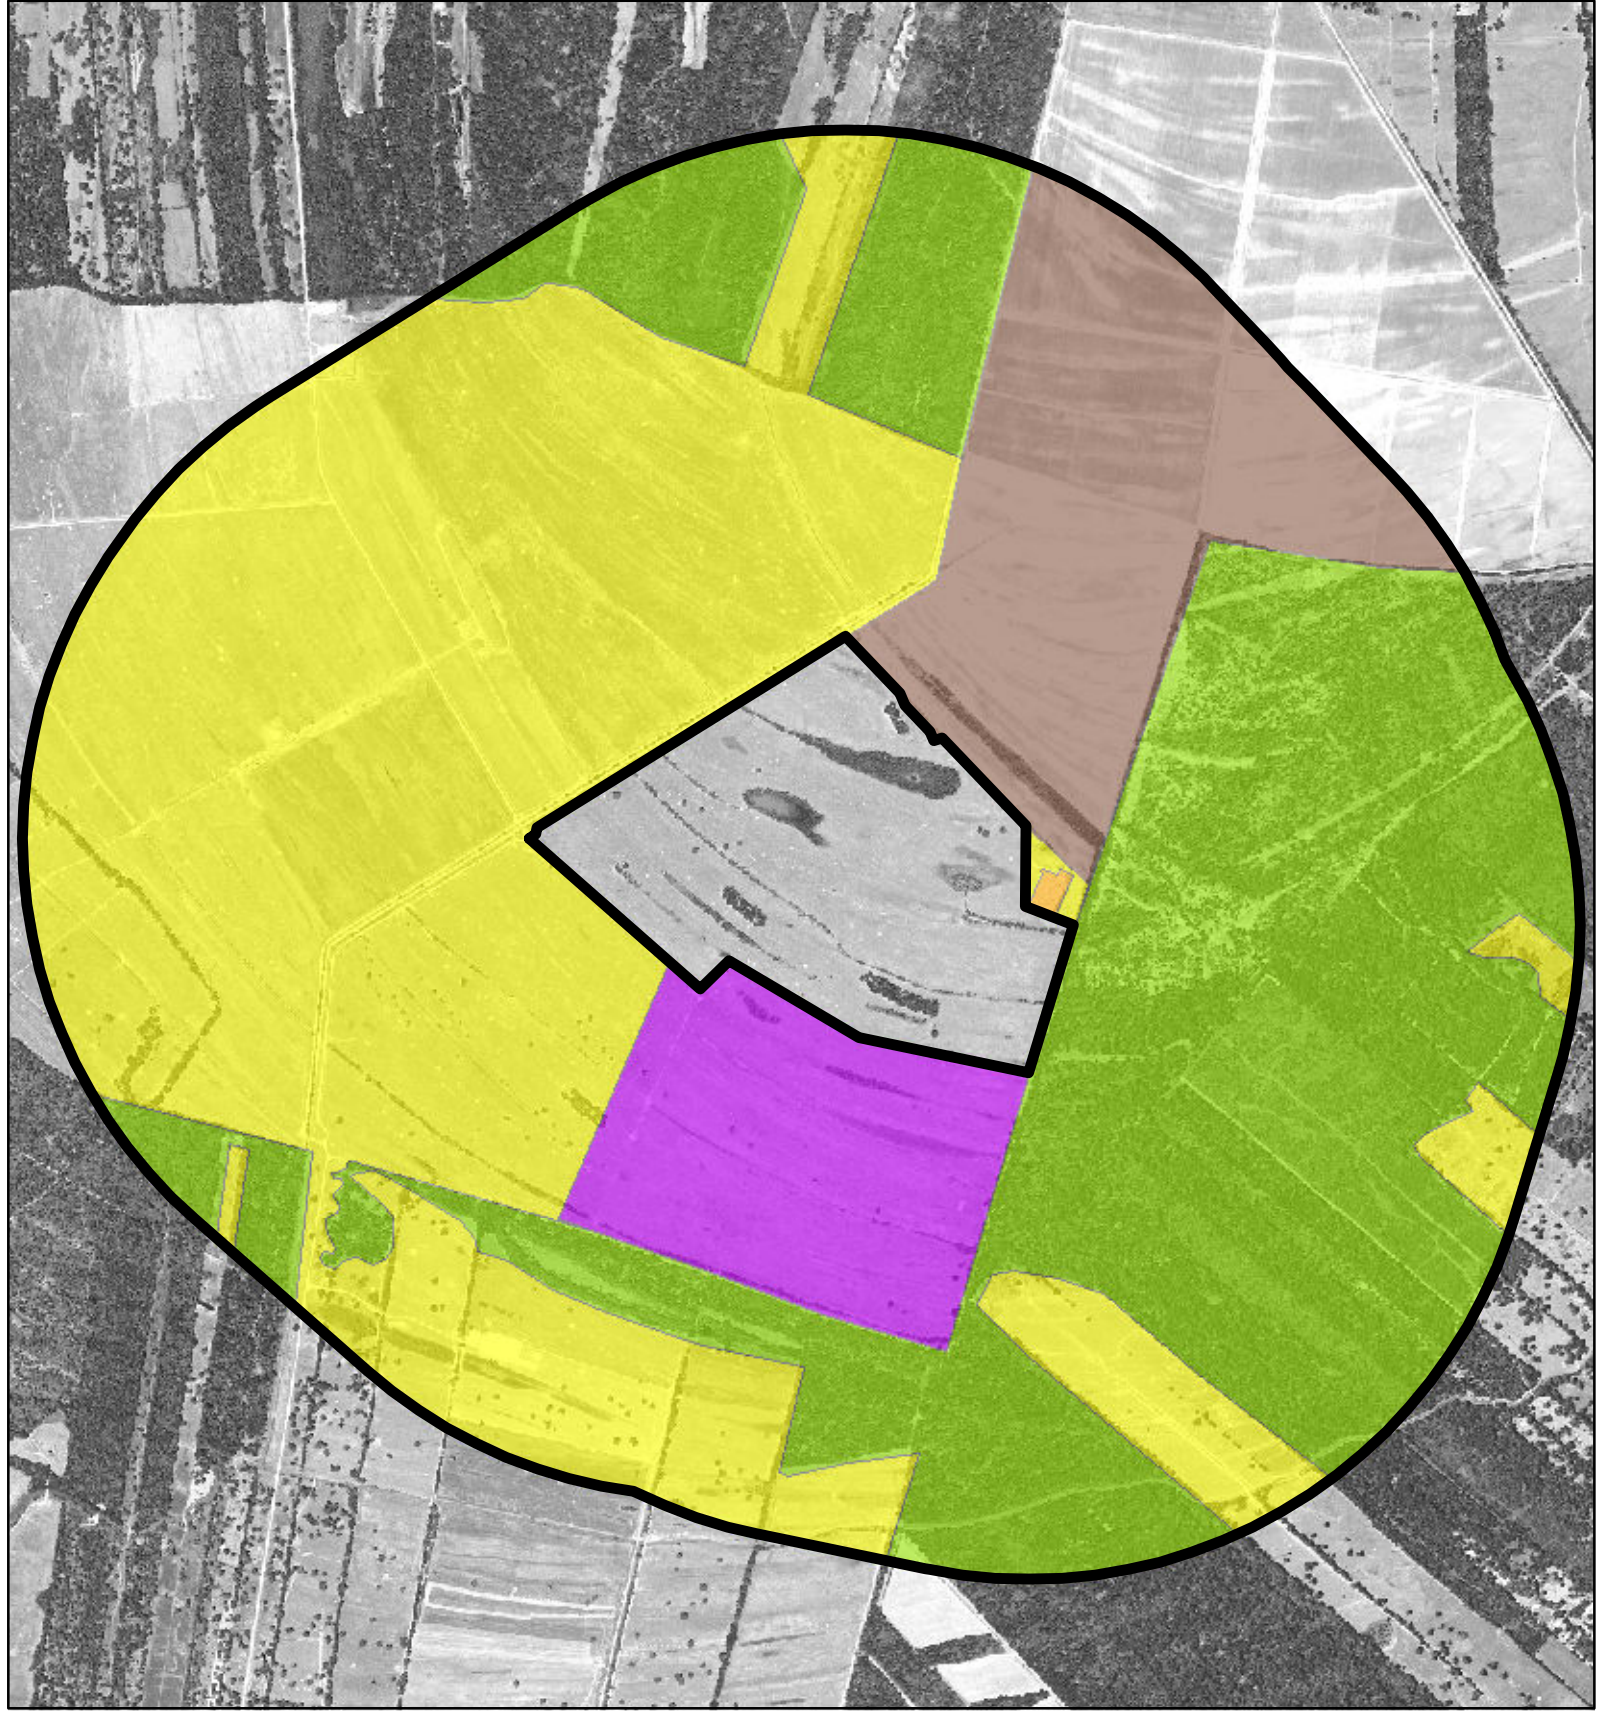
FIGURE 6

- On November 30, 2012, a perpetual conservation servitude was executed on 27.6 acres of pasture adjacent to the Bank site in association with a Permittee-Responsible Mitigation (PRM) Project. With the existing 248.5-acre servitude executed earlier in 2012, this brings the total acreage of conservation servitude adjacent to the Bank to 276.1 acres. Changes were made to Sections II and III of the MWP and in Attachment MWP-A Figure 6 (*Surrounding Land Use within One Mile Radius*) to reflect this.

- Pasture/ Hay (44.90%)
- Woody Wetlands (36.49%)
- Cultivated Crops (11.41%)
- Existing Wetland Mitigation Sites (7.12%)
- Developed, Low Intensity (0.08%)

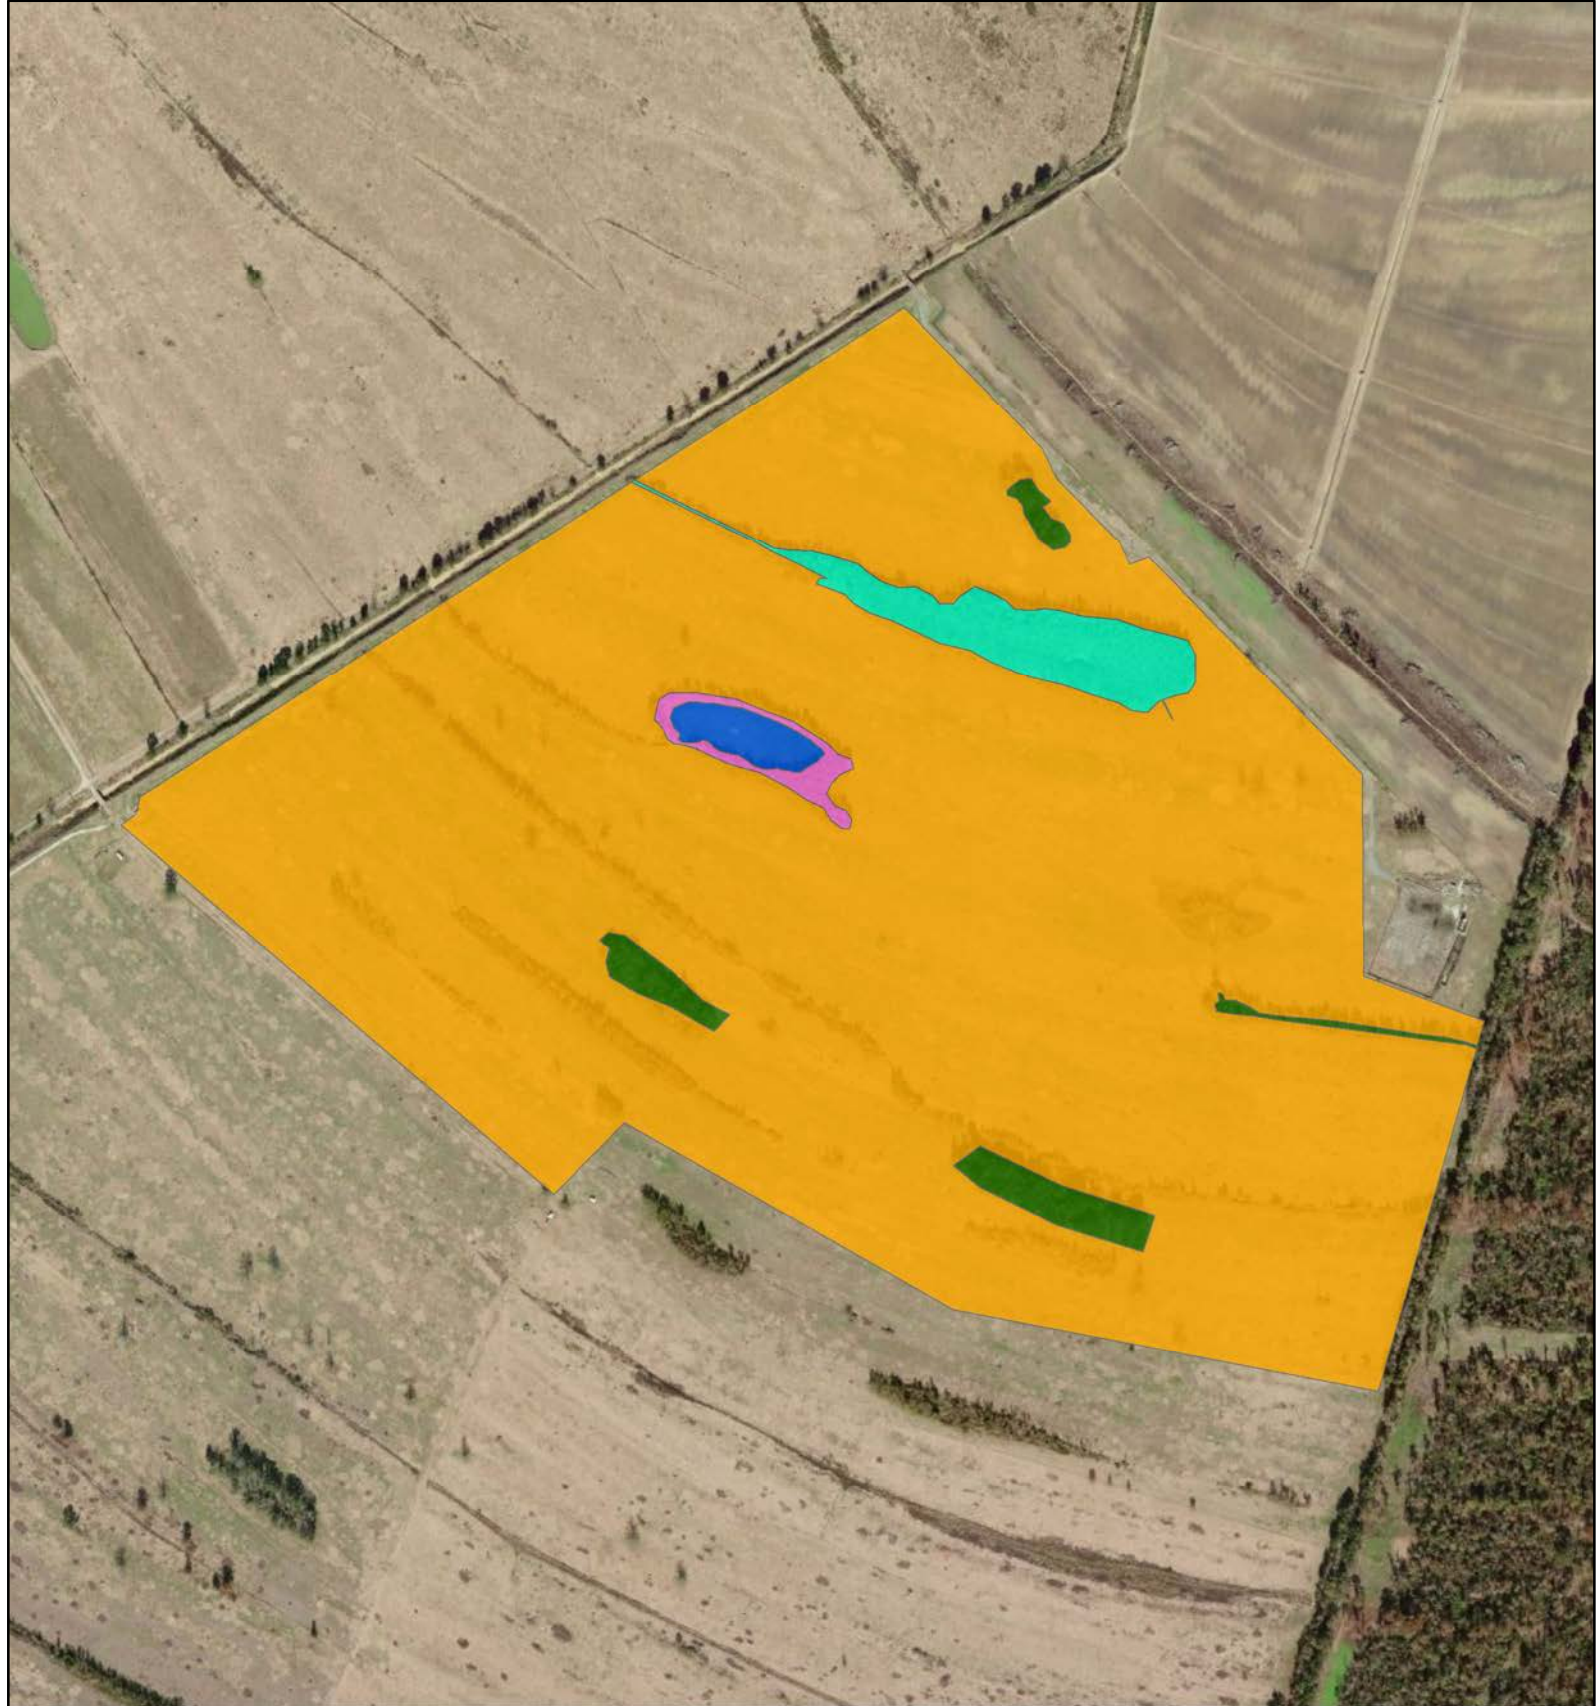
FIGURE 17

- Improved Pasture (304.0 Acres)
- Bottomland Hardwood Forest (6.1 Acres)
- Chinese Tallow Forest (9.2 Acres)
- Black Willow Forest (2.1 Acres)
- Open Water (2.4 Acres)

EXISTING CONDITIONS
